FOUNDATION SEISMIC RETROFIT OF BOEING FIELD CONTROL TOWER

ABSTRACT: The existing control tower at King County International Airport in Seattle, Washington, was severely damaged during the Nisqually Earthquake, February 28, 2001. As a result of the damage, the control tower was immediately closed and the existing timetable for a seismic retrofit of the control tower was expedited. The existing tower and associated support structures were founded on timber piles of unknown lengths (probably extending to depths between 25 and 35 feet); subsurface explorations indicated liquefiable soils to a depth of approximately 35 feet. The foundation retrofit included compaction grouting to densify the loose, liquefiable sands beneath the existing structures and the installation of drilled shafts adjacent to the tower to support the new structural steel bracing which was added to increase the resistance of the tower to overturning during the design earthquake. With the air traffic control operations being performed in a temporary facility, the urgency of performing the retrofit led the Federal Aviation Administration to negotiate a contract directly with the general contractor. This paper address

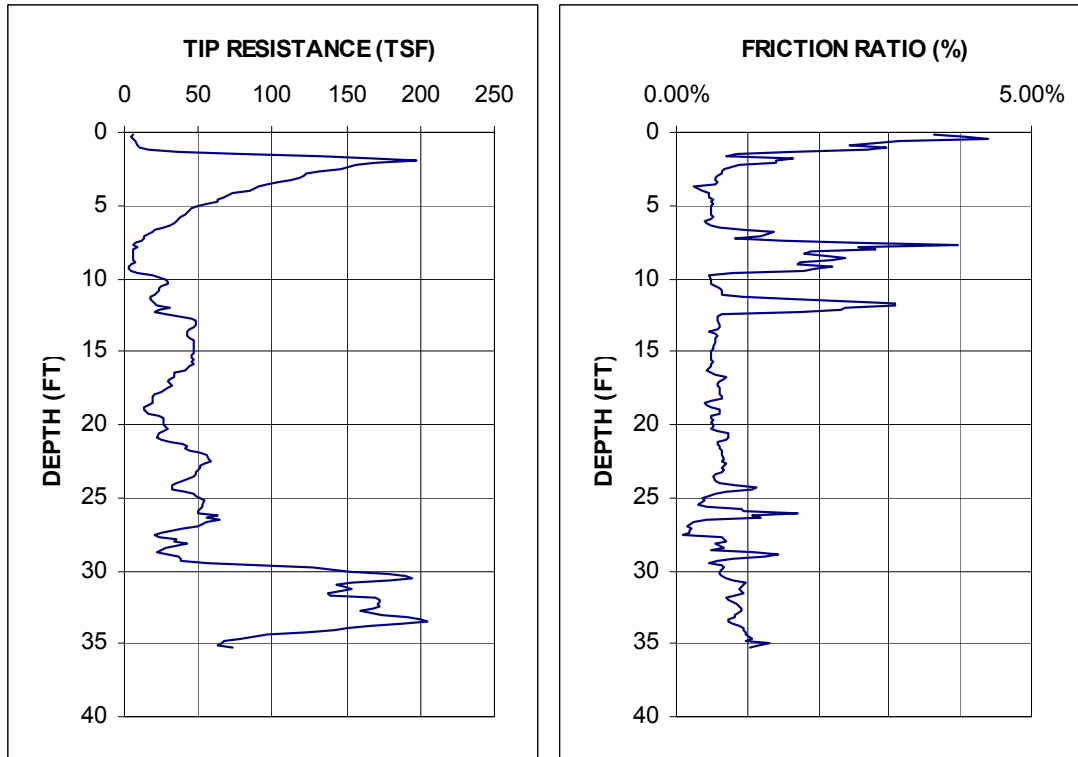
FIG. 2. CPT-01 PRE-TREATMENT RESULTS

A graph of the raw values for the pre-treatment CPT-01 is shown in Figure 2. The graph of the friction ratio indicates that the material from 15 to 25 ft has a friction ratio less than 0.75% which indicates a clean sand which is very amenable to improvement by compaction grouting. The material from 25 to 30 feet has several spikes greater than one in the friction ratio which indicate a layering of the clean sand with silty material, and the material from 30 to 35 feet has a friction ratio of just under 1% which indicates a silty sand. The silty material has a lower permeability

which inhibits the effects of densification by reducing the rate at which excess pore pressures dissipate during the injection of the grout bulb.

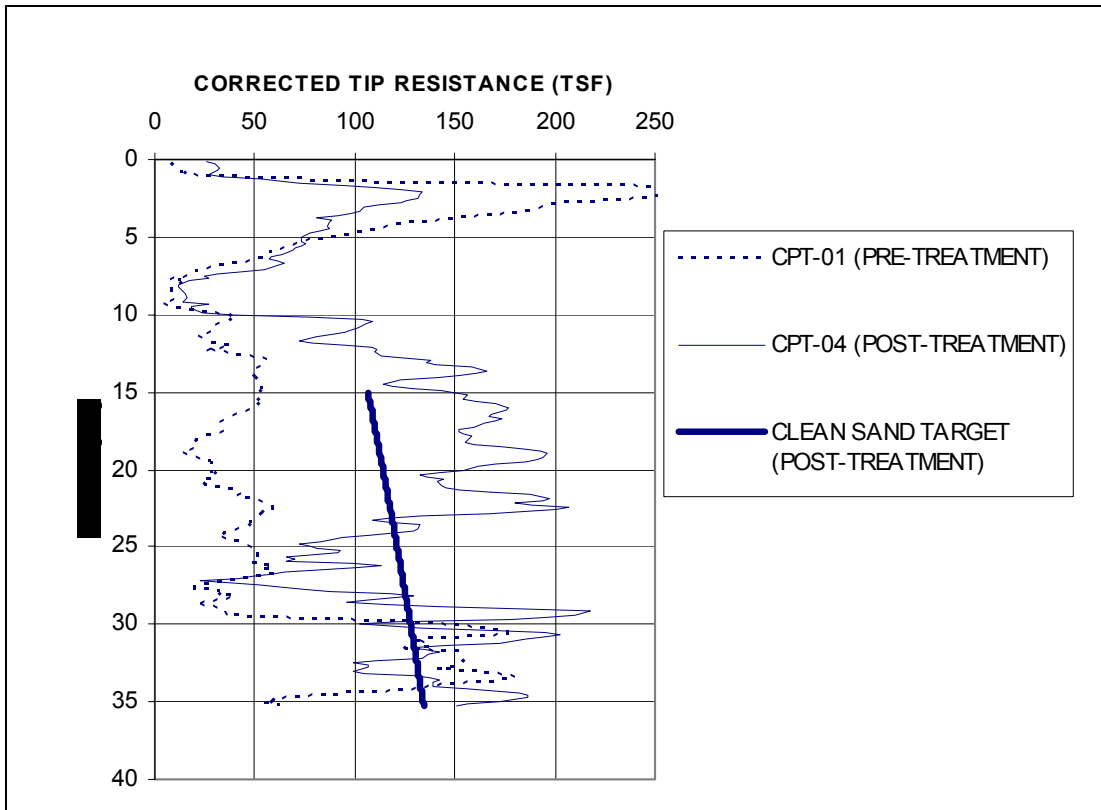
FIG. 3 . COMPARISON OF PRE-TREATMENT AND POST-TREATMENT CPTS

The corrected tip resistance for the pre-treatment CPT-01 and the post-treatment CPT-04 performed on the east side of the tower are shown in Figure 3 along with the target value of the post-treatment CPT. The post treatment CPTs used to measure the performance of the compaction grouting indicated generally acceptable levels of improvement as compared to the required performance level. There are zones in the treatment zone between 25 and 35 ft where the required densification was not achieved. In fact, the pre and post treatment CPTs show little difference at 28 ft. This zone of no improvement corresponds well with the fine grained soil layers indicated by the higher friction ratios recorded in the pre-treatment CPT. Although the CPT's showed improvement which generally met the performance requirement, the presence of some zones of material which did not achieve the required performance led to some remedial points being added in the critical area of the control tower.
