## **Stabilization of Running Granular Soils in TBM Alignment with Sodium Silicate Grout**

Brendan P. Harkins<sup>1</sup>, E.I.T.; Dominic M. Parmantier<sup>2</sup>, M. ASCE, P.E.

**ABSTRACT:** During the tunnel boring machine (TBM) excavation of the Portsmouth Forcemain Segment 2, in Portland, Oregon, the Lovat TBM encountered free flowing granular material including cobbles and boulders which resulted in excessive ground loss. Prior to stopping the TBM, the uncontrolled ground loss had resulted in a chimney opening up to the ground surface 24.4 m (80 ft) above the tunnel crown. Previous attempts at using polyurethane grouts from the face of the machine had been unsuccessful in controlling the ground loss associated with tunnel advancement. The tunneling contractor selected a grouting proposal which ultimately relied on sodium silicate grouting to stabilize the loose granular soils above the water table with an array of vertical and battered sleeve port pipes installed from a walking trail on the slope above the TBM. Drilling methods included a casing advancement system to deal with the expected cobbles and boulders in the tunnel alignment. Significant grout losses occurred in t

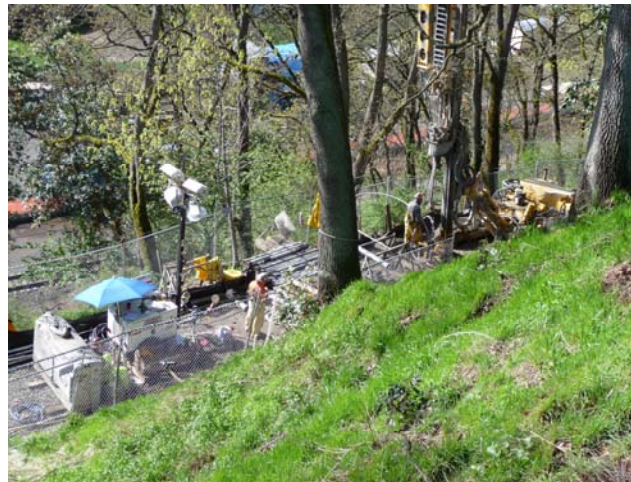
**FIG. 2: Work Bench**

All equipment access to the work area was a city street, which intersected the walking trail approximately 91.4 m (300 ft) from the drilling location. To prevent the degradation of the walking trail under the tracks of the drill rig, cane mats were positioned between the rows of grout holes. Water was also channeled to one location in the work area, where piping carried it down the hillside and into a baker tank, at the bottom of the slope. Figure 2 shows the drilling operation as it is being performed on the work bench.

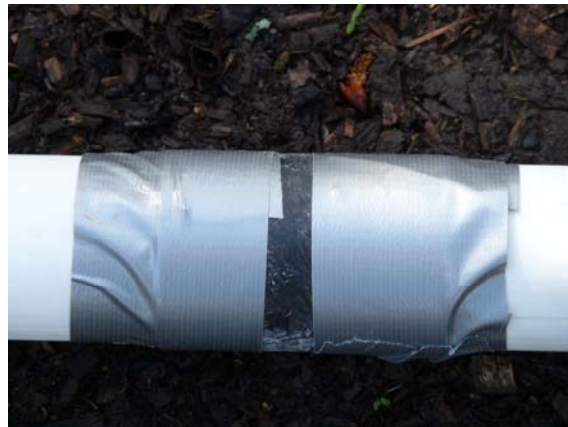
**FIG. 4: Typical Sleeve Port**

Sleeved port pipes also known as tube a manchette pipes or TAMs provide access for the controlled injection of the sodium silicate grout. The SPPs were constructed by drilling four holes around the circumference of the PVC pipe and covering them with a rubber sleeve which prevented the backfill grout from entering the pipe and also acted as a one way valve during grout injection as shown in Figure 4.

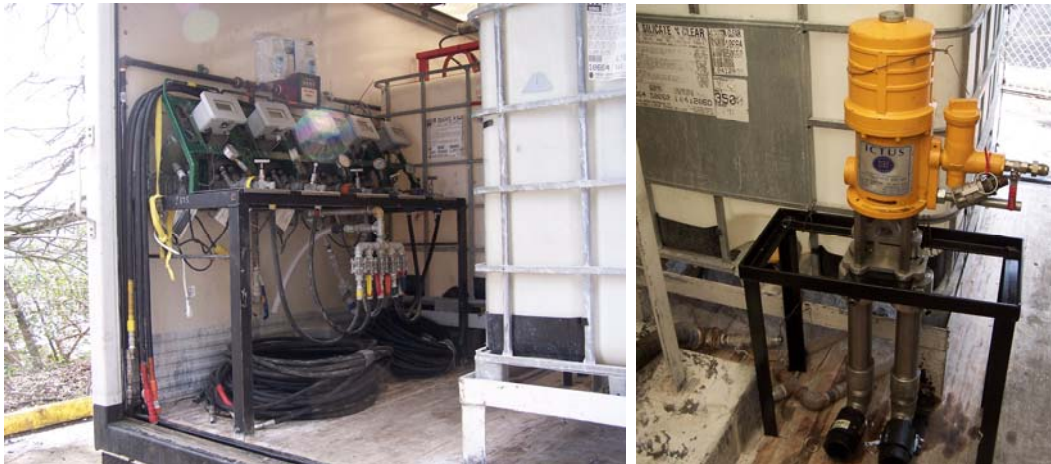
**FIG. 6: Grout Truck and Dual Piston Pump**

The setup for the Portsmouth grouting was a challenge given the steep hillside and the narrow work platform. It was important to minimize the amount of equipment and material on the working platform to maximize the working space. The sodium silicate was held in a tanker that was parked at the top of the hill and gravity fed down the hillside to the grouting location. Likewise, the reactant was stored at the top of the hill and pumped directly from the storage totes down the hillside. Both the sodium silicate and the reactant were mixed with water in the appropriate proportions and held in separate totes in the back of a box truck (Figure 6) at the grouting location. The box truck contained a dual piston pump, for mixing and pumping the grout, as well as flow meters and pressure gauges to monitor the grouting. Grout was pumped from the totes, that received that material from the top of the hill, through the

valve bank and then into the ground through a straddle packer. The grout mix for this project contained 45% water, 40% sodium silicate, and 15% reactant, by volume. There were four totes in the back of the grout truck for batching and pumping the grout. Two of the totes would receive the material from the top of the hill for mixing with water and the other two would feed the material into the pump for placement.

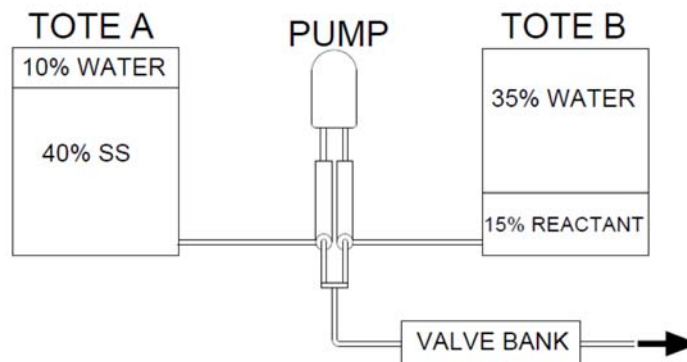
**FIG. 7: Mixing and Pumping Configuration for Sodium Silicate Grouting**

The sodium silicate was mixed with water in the first receiving tote to create a 40% sodium silicate and 10% water solution which was transferred to the sodium silicate feed tote (Tote A). The reactant was mixed with water in the second receiving tote to create a 15% reactant and 35% water solution which was transferred to the reactant feed tote (Tote B). The solutions in Tote A and Tote B were then pumped and mixed together in a single grout line to form the activated chemical grout as illustrated in Figure 7.

The grout was pumped through a valve bank that split the grout flow into multiple lines, allowing for as many as five sleeve ports to be grouted simultaneously. The valve bank also contained flow meters for tracking the volume of material as well as the pressure contained in each of the grout lines. The target volume at each of the sleeve ports was 0.4 cubic meters (14 cuft), based on a 30% void ratio and a grout spread of 0.8 m (2.75 ft). Grouting began at the bottom sleeve port, at the spring line of the tunnel, and moved up incrementally until all the ports had either achieved the target volume, exceeded a pressure of 0.7 bar (10 psi) above residual fracture pressure, and sustained flow less than one gallon per minute, or grout was seen either returning to the surface or leaking into the TBM.
